Synergetics of in-service titanium alloys fatigue cracking.

A. Shanyavsky,

*State Center for Civil Aviation
Flights Safety, Russia.*

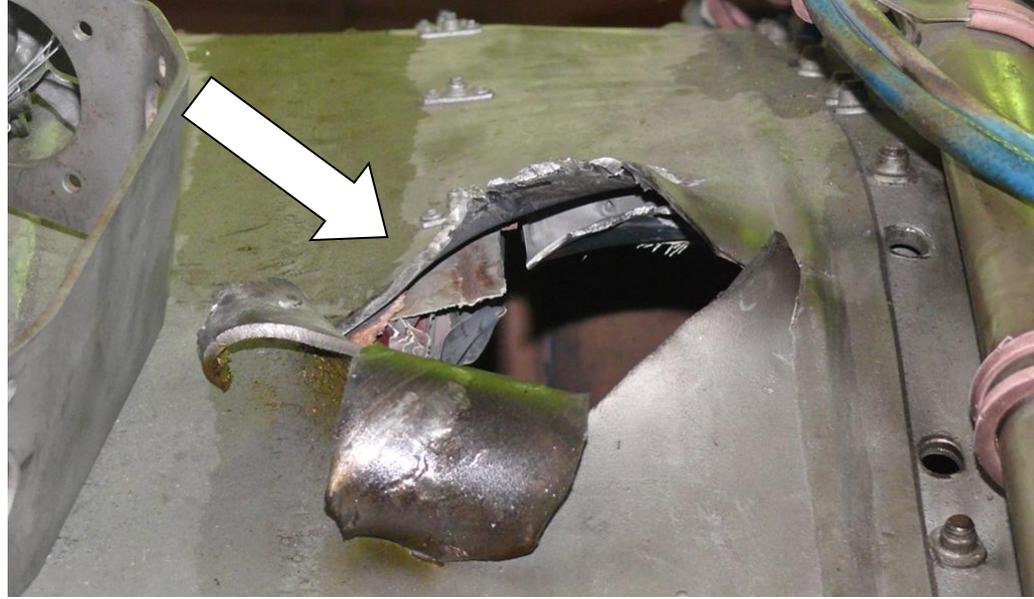
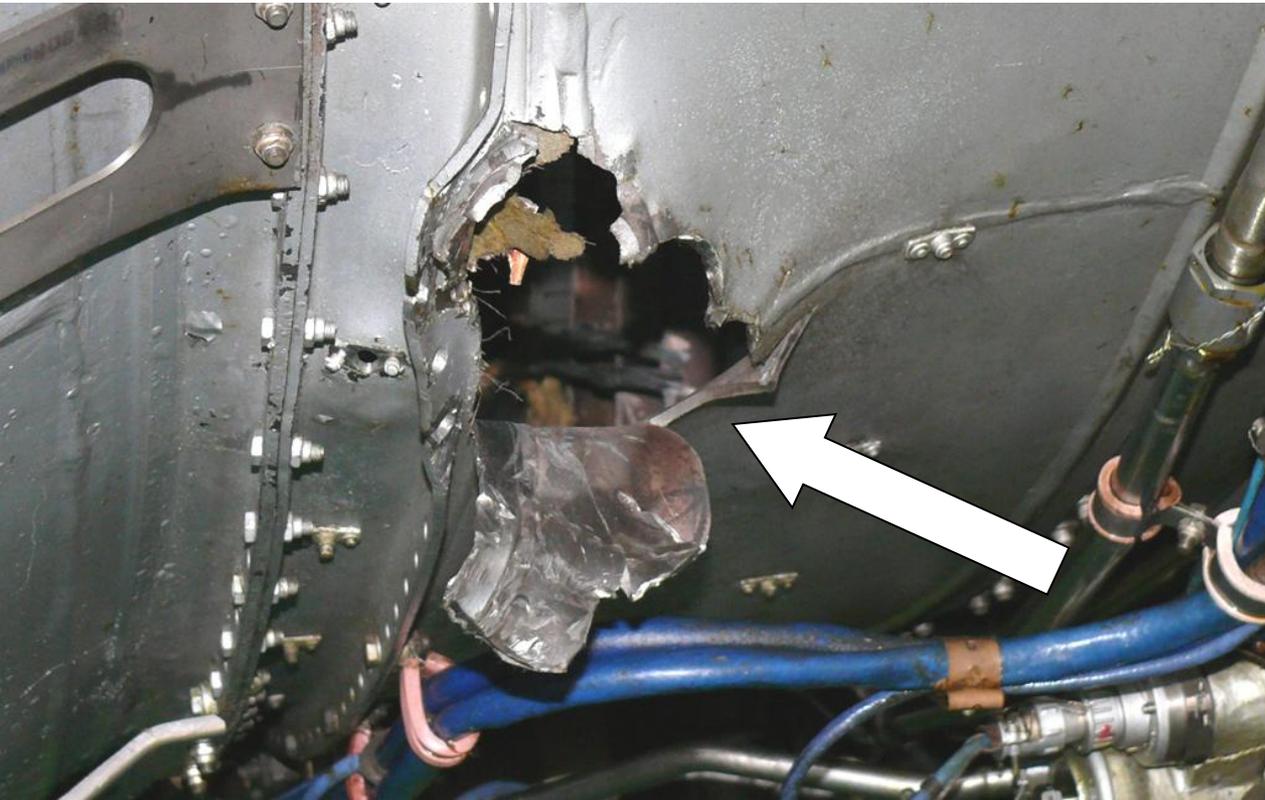
Out-site overview of non-localized failure areas (shown by arrows) of the engine D-18T casing due to parts of in-flight went-out fragmented rim of the titanium disk of the LPC second stage (June 2010).

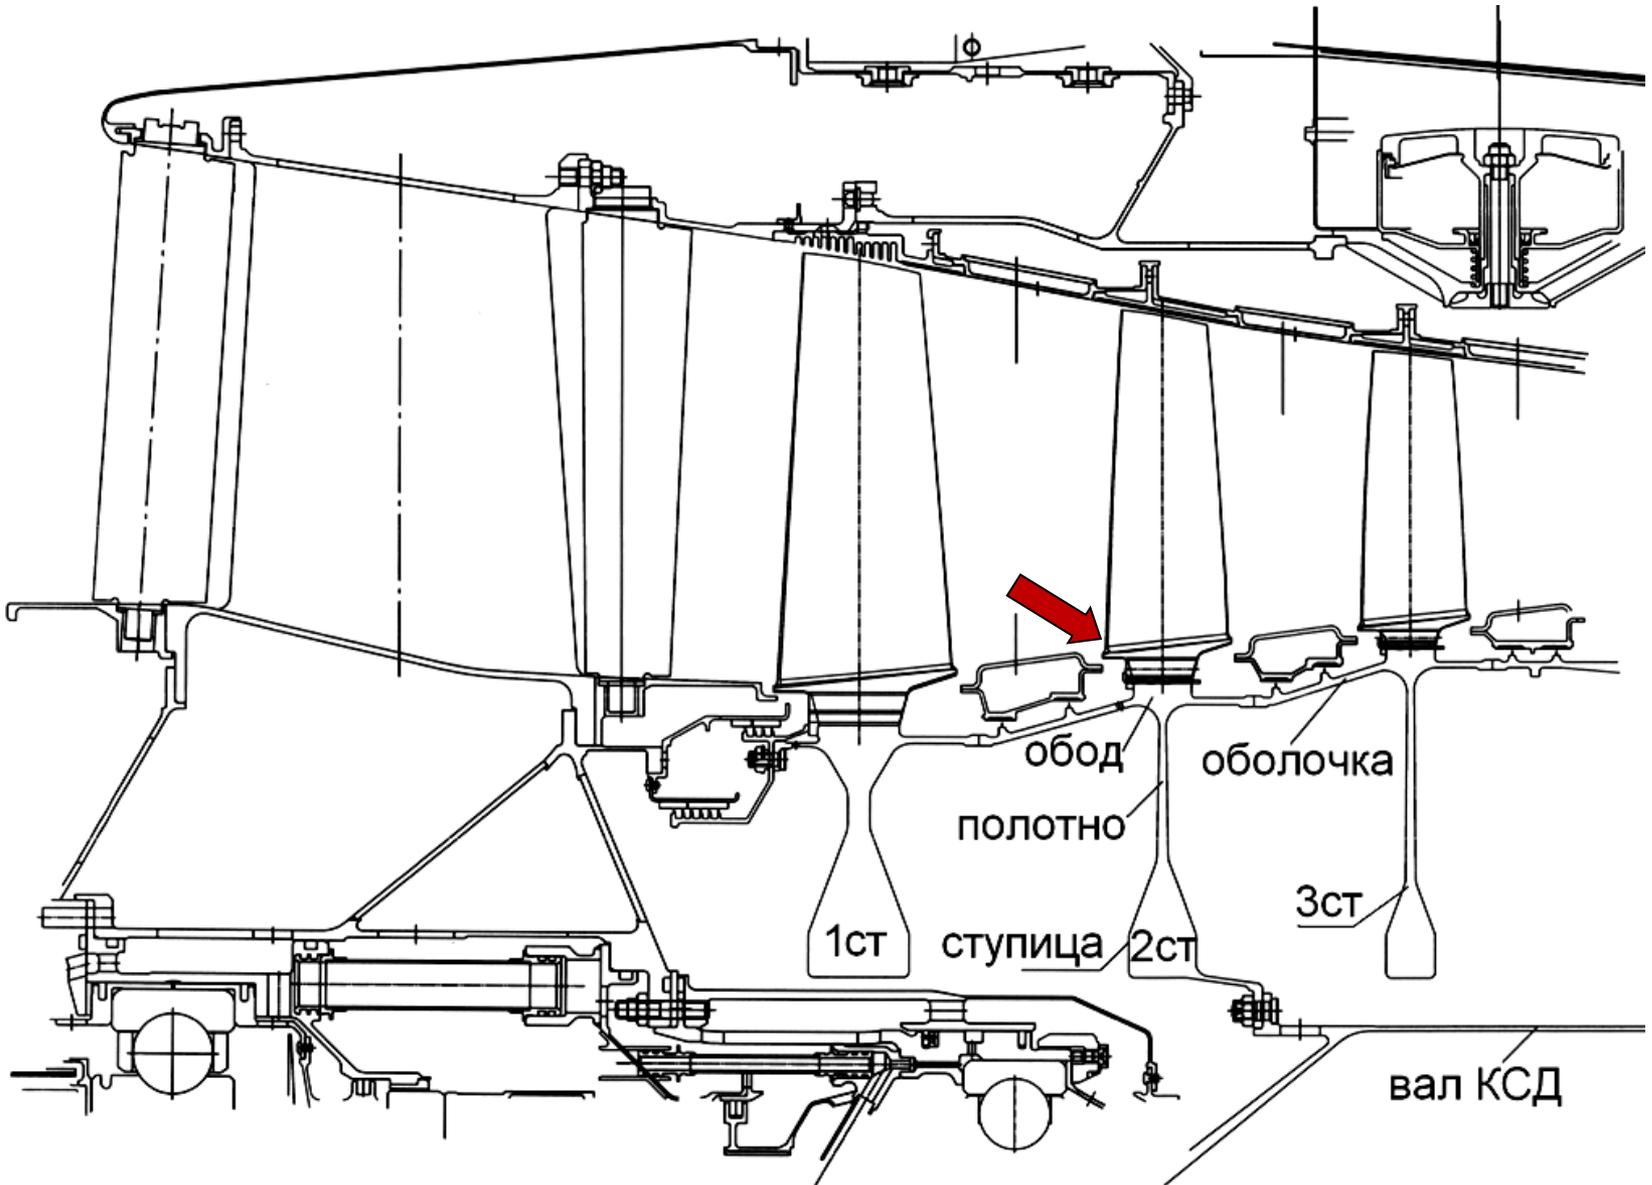
Schema of several LPC stages of aircraft engine D-18T.
The red arrow pointed out area of the second stage LPC cracking.

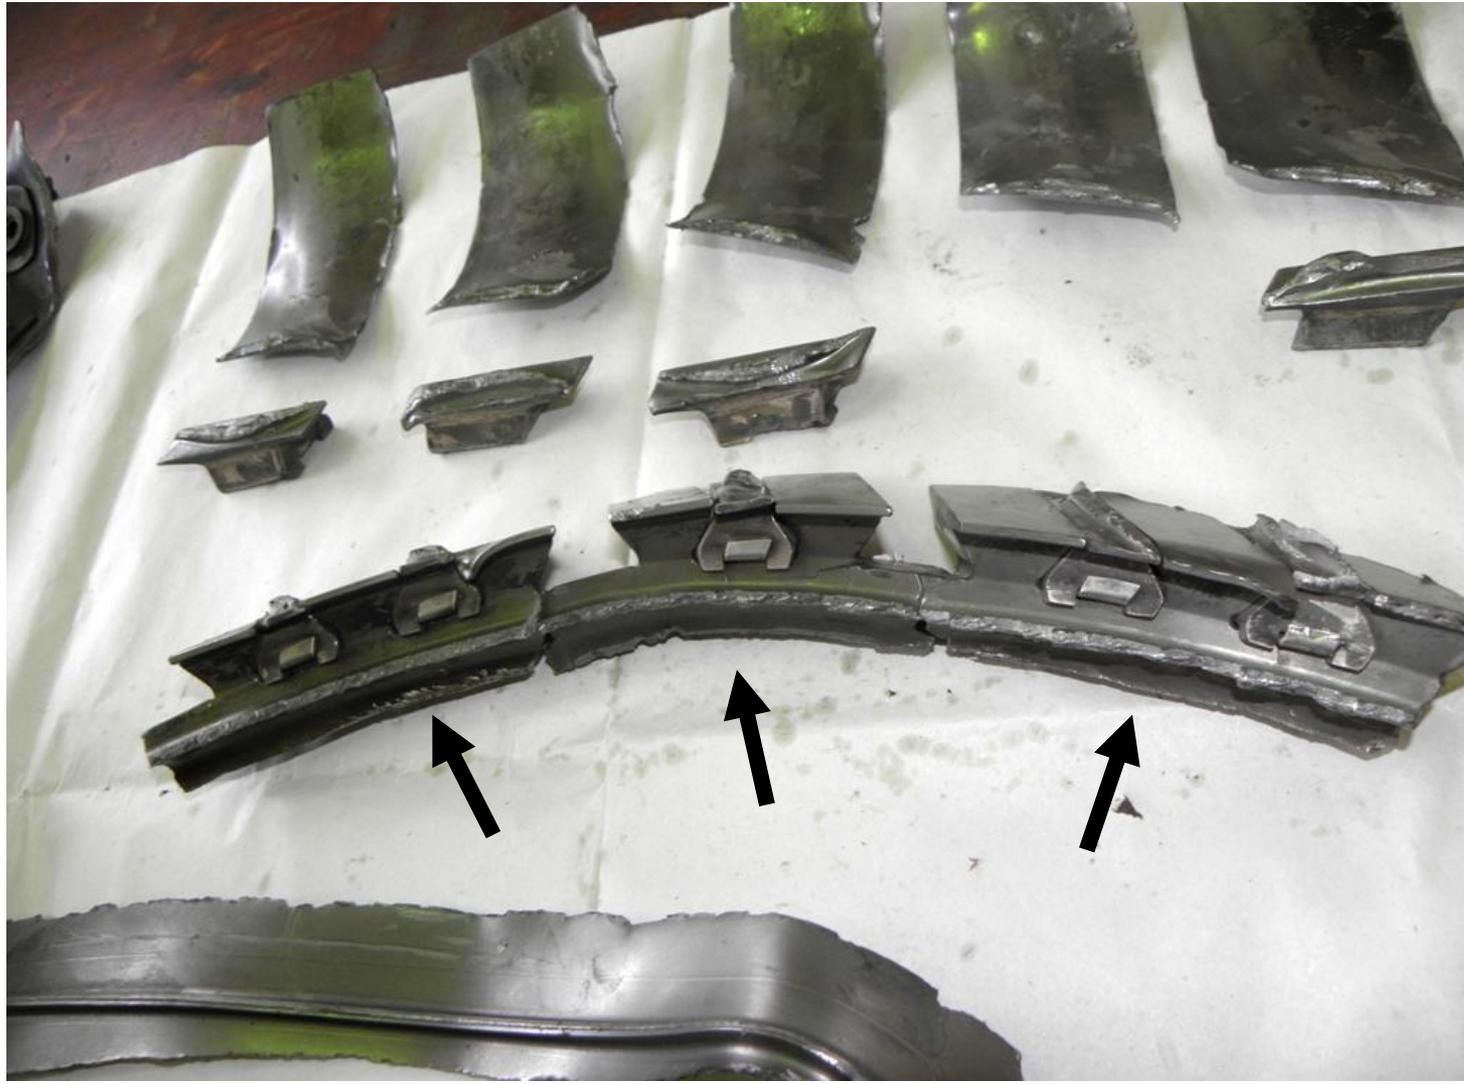
Overview of several connected fragments (shown by arrows) of the failed titanium disk rim of the second stage LPC with several crashed blades

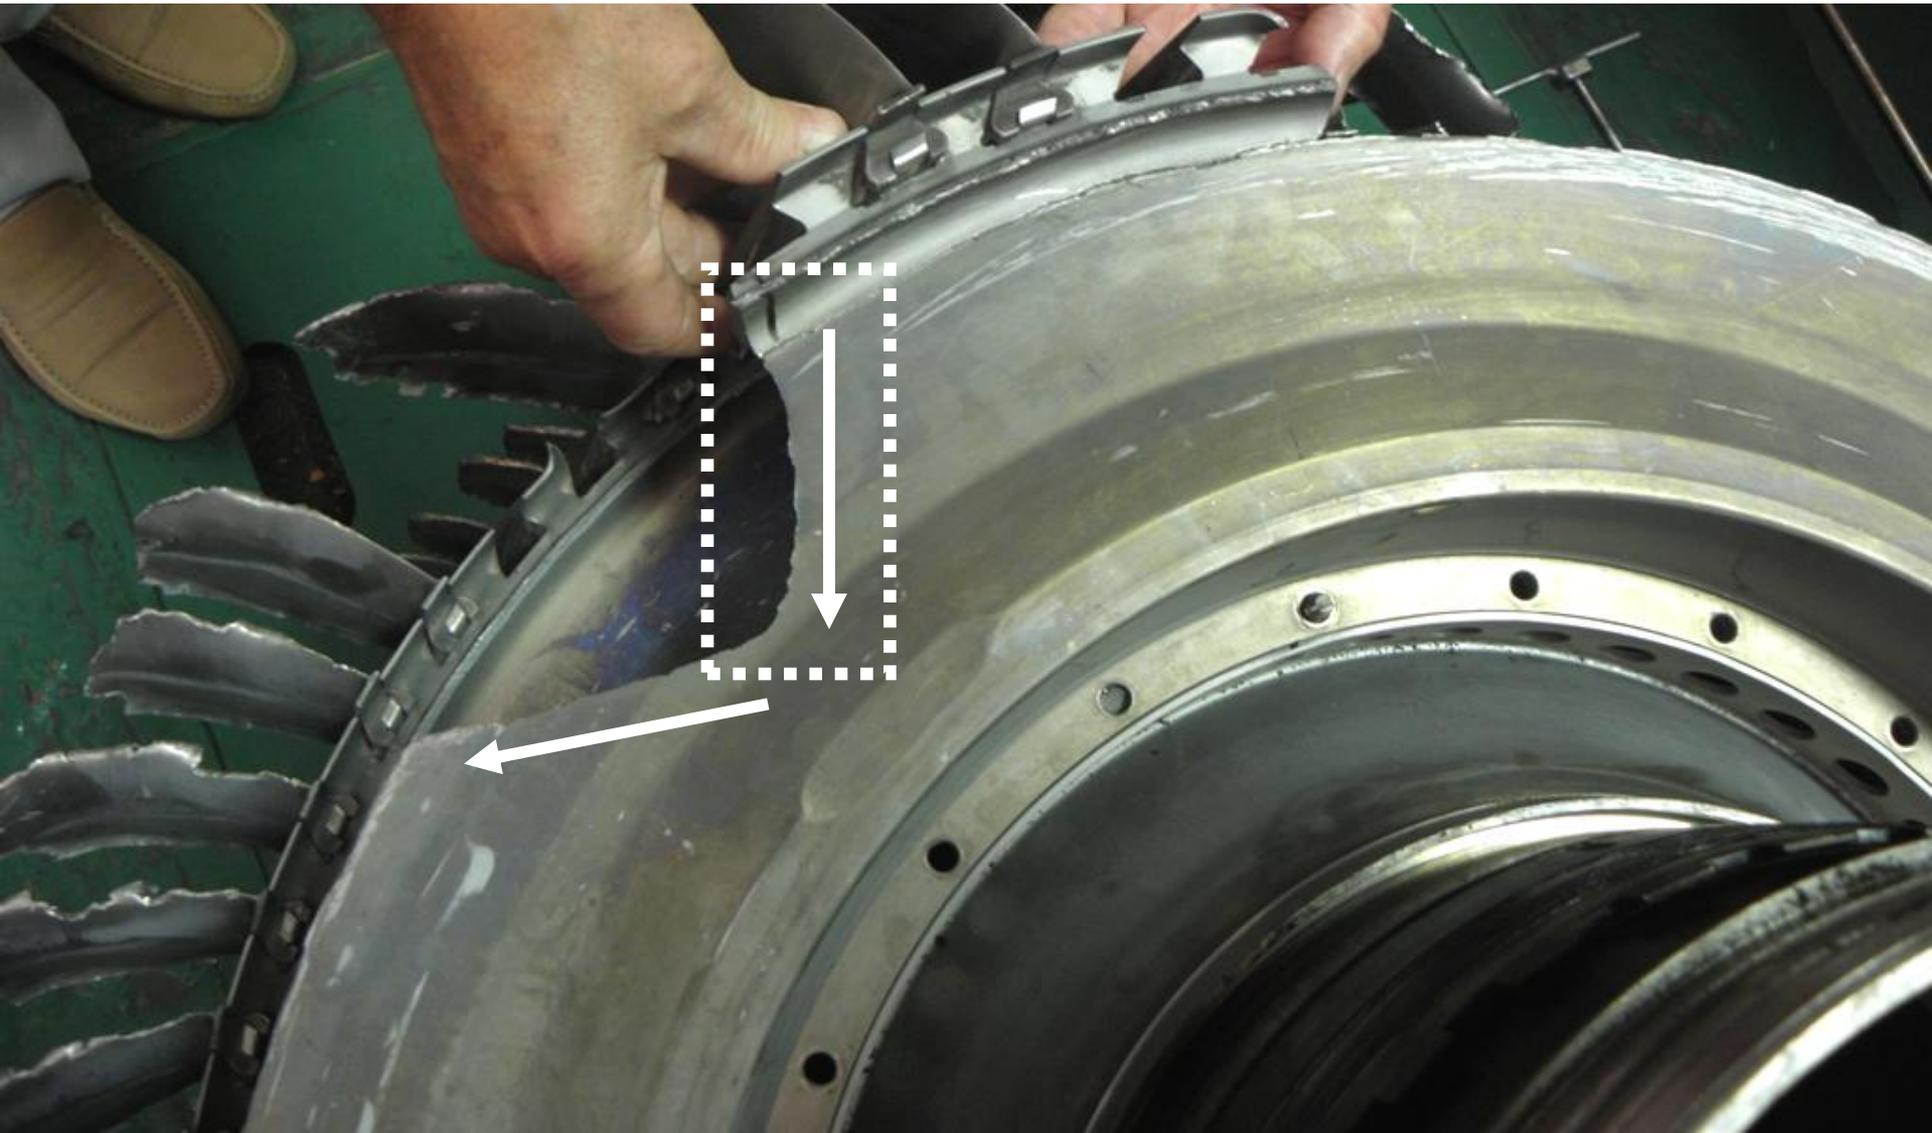
AREA OF THE FIRST STEP OF TITANIUM DISK CRACKING

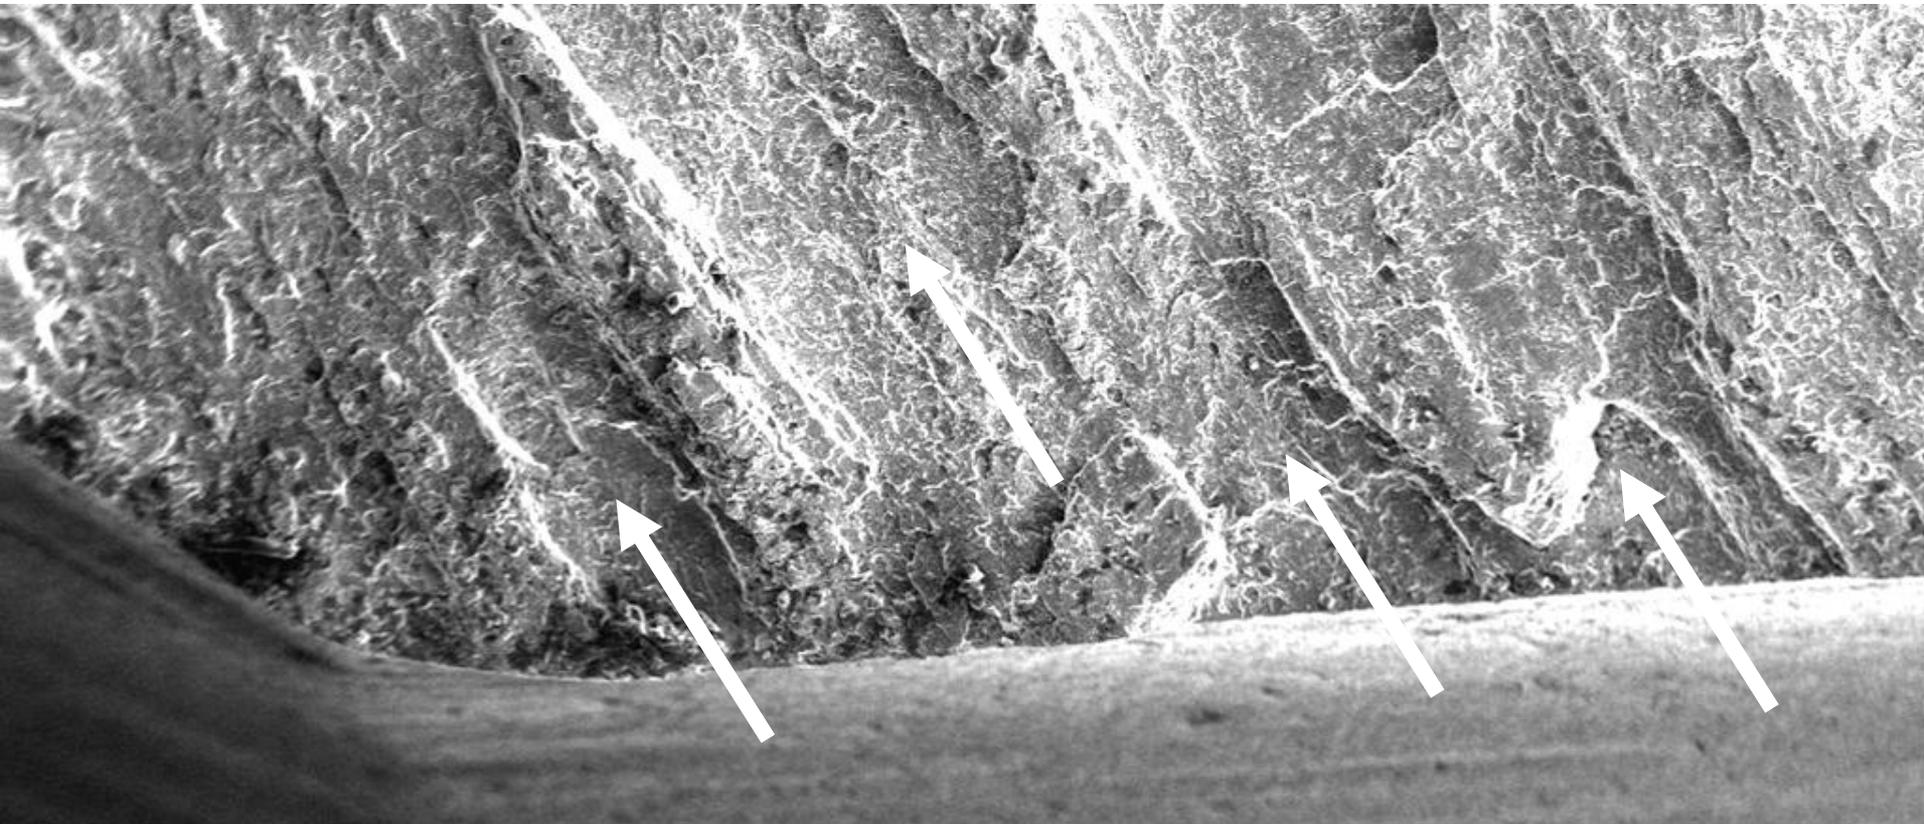
MESOTUNNELS FOR FATIGUED DISK IN LCF REGIME

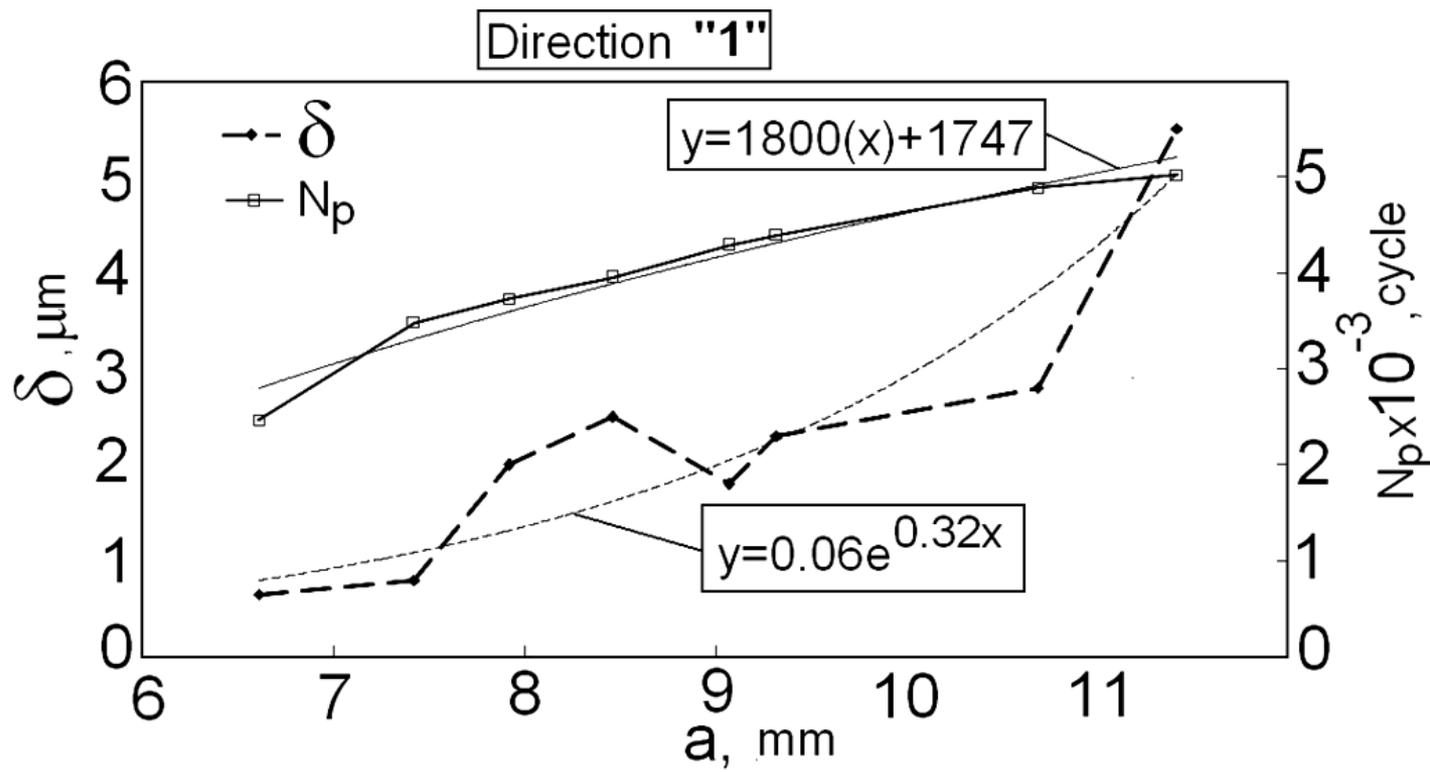
NUMBER OF CYCLES HAS BEEN DETERMINED BASED ON FATIGUE STRIATIONS COUNTING

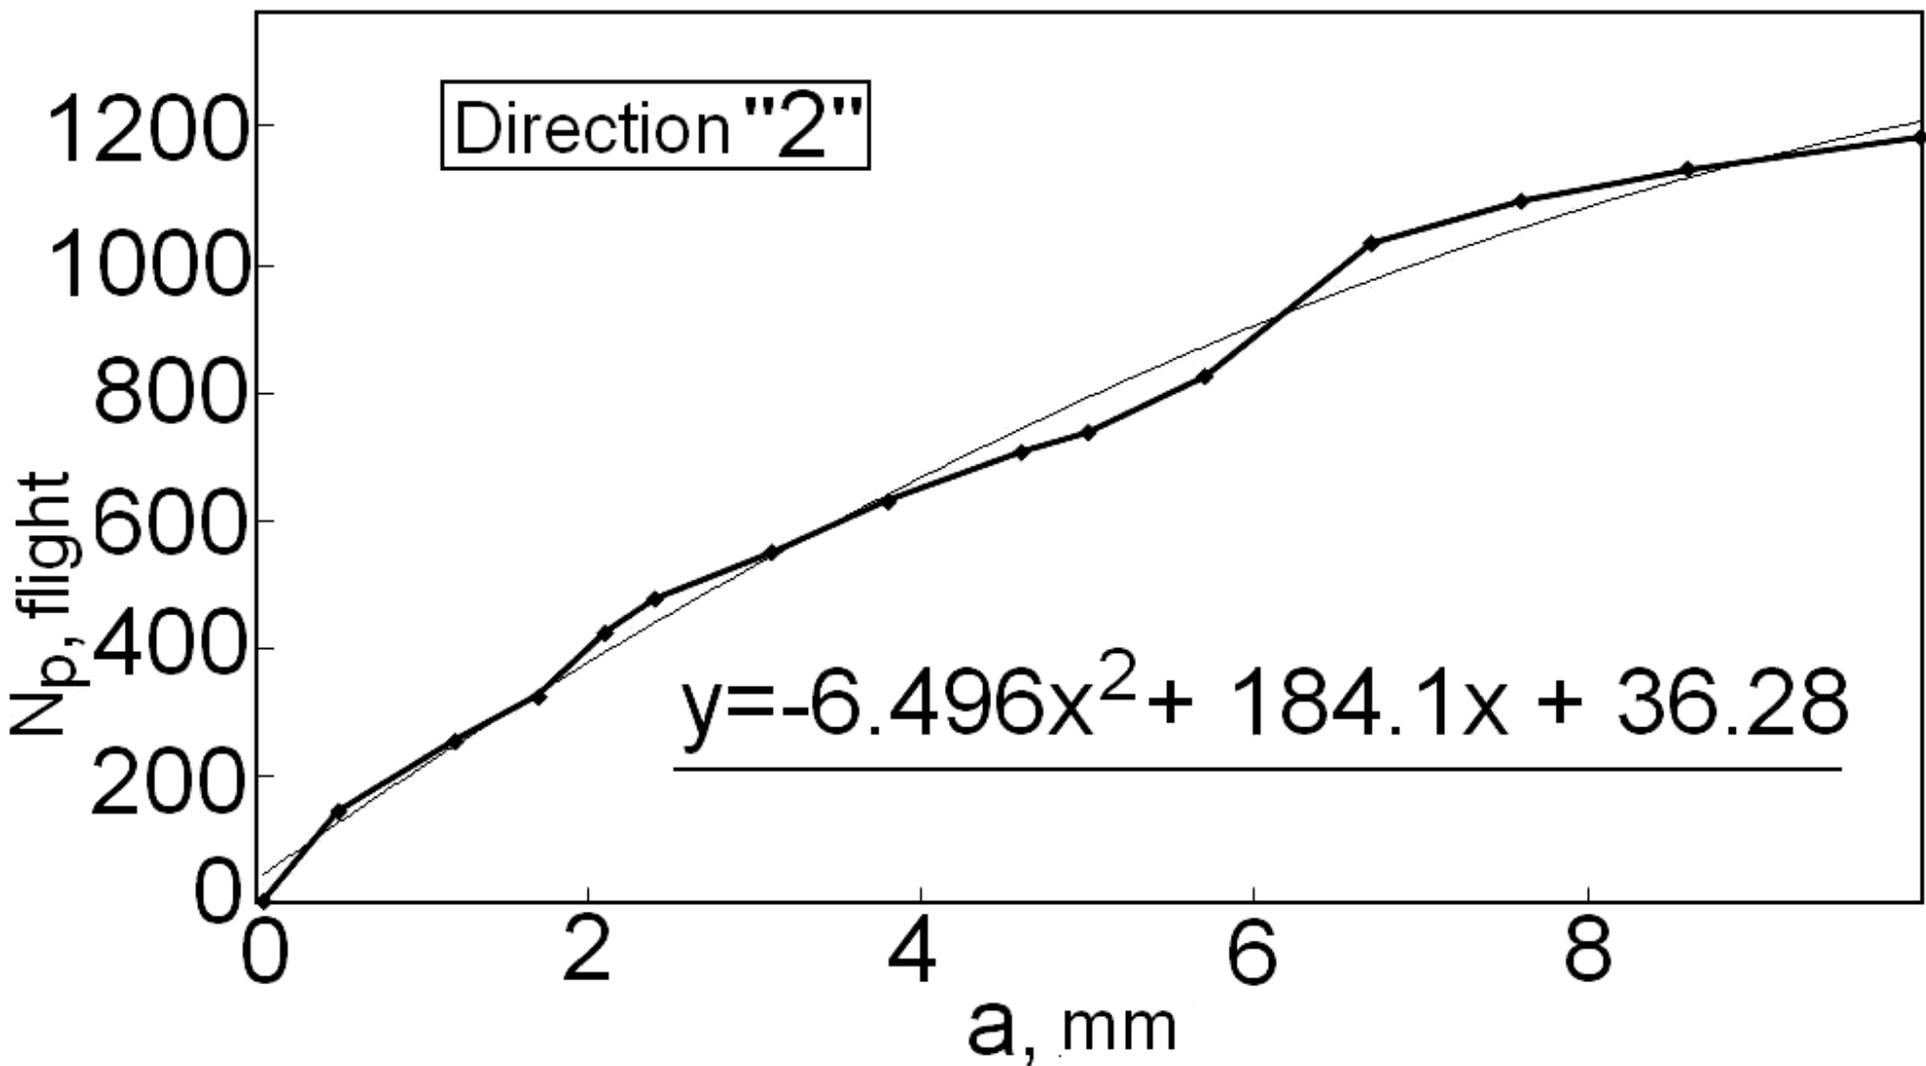
NUMBER OF FLIGHTS HAVE BEEN ESTIMATED WITH
DECREASING NUMBER OF STRIATIONS ON FACTOR 8.0

BECAUSE OF **LCF** HAS TAKEN PLACE FOR TITANIUM DISKS, NON-DESTRUCTIVE INSPECTION ALL FLEET TITANIUM DISKS OF THE SAME TYPE WITH INTERVAL **200 FLIGHTS** CAN BE INTRODUCED FOR RELIABLE AND SAFETY AIRCRAFT FLIGHTS

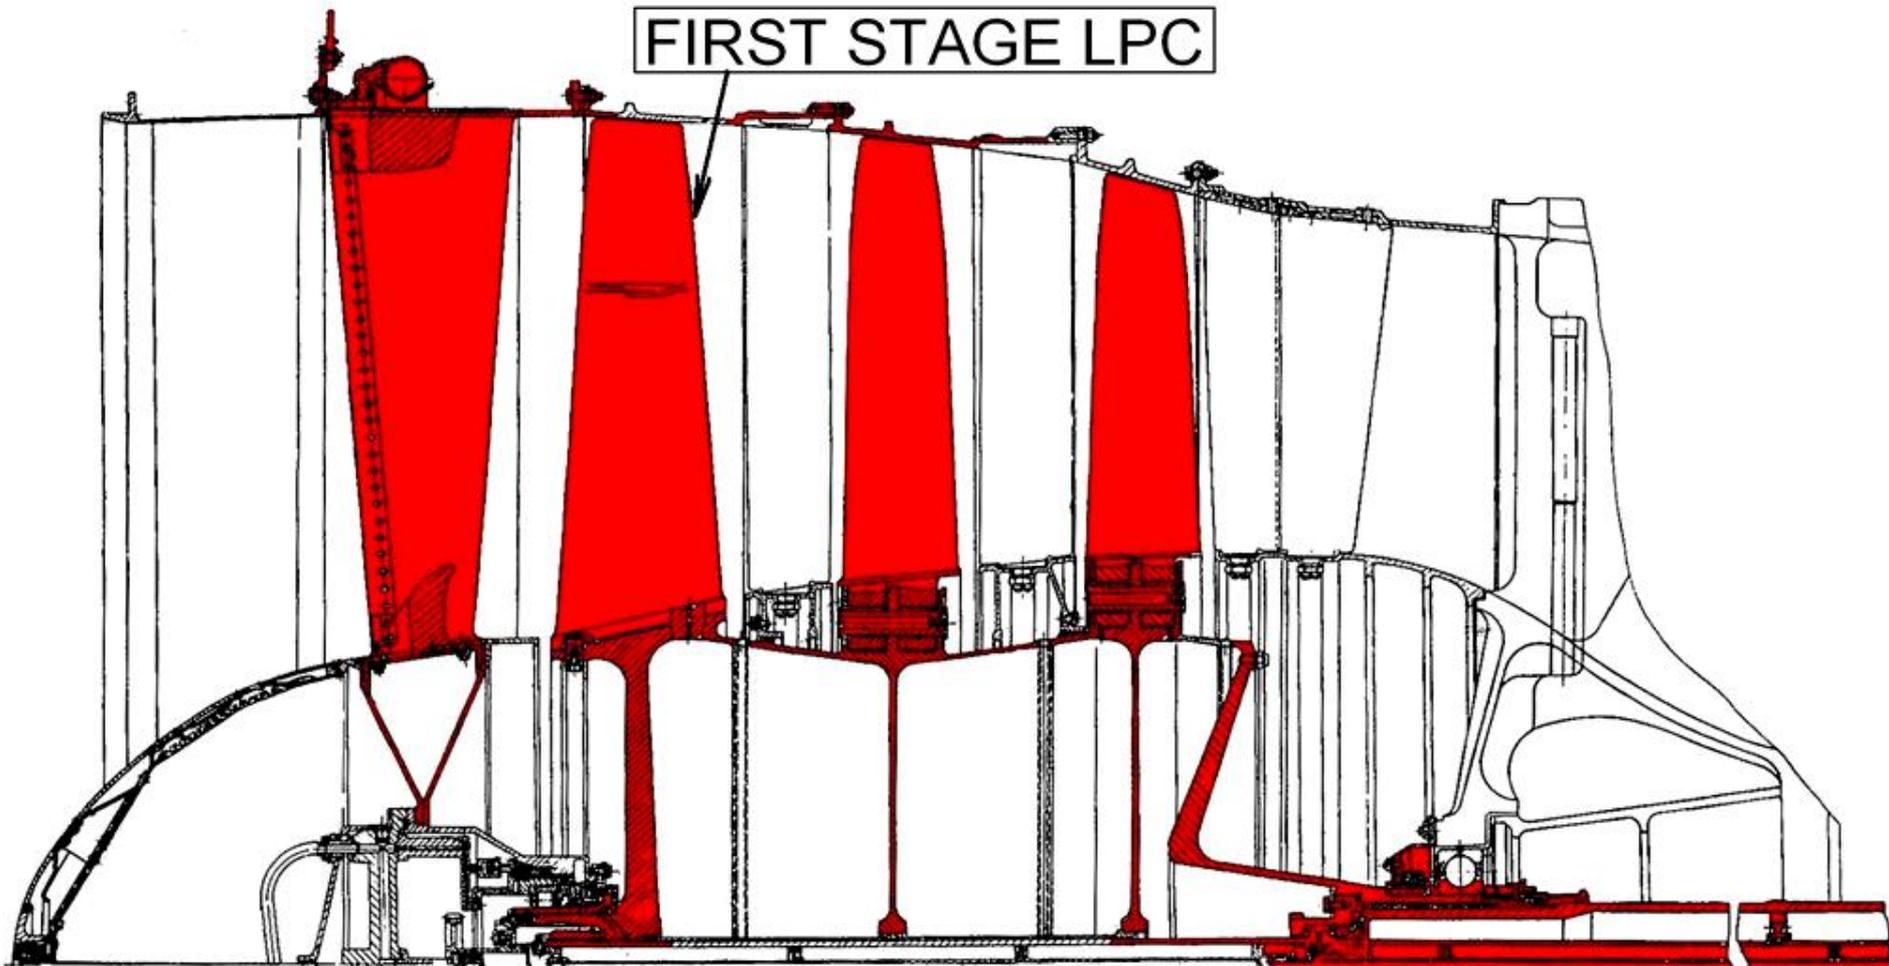
**TITANIUM DISKS FAILURES
IN HCF-LCF REGIME; ENGINE D-30KU**

NUMBER OF FLIGHTS: No1 – 1000;
No2 – 6100;
No3 - 9700

AIRCRAFT ENGINE D-30KU-154 FOR THE AIRCRAFT TU-154B

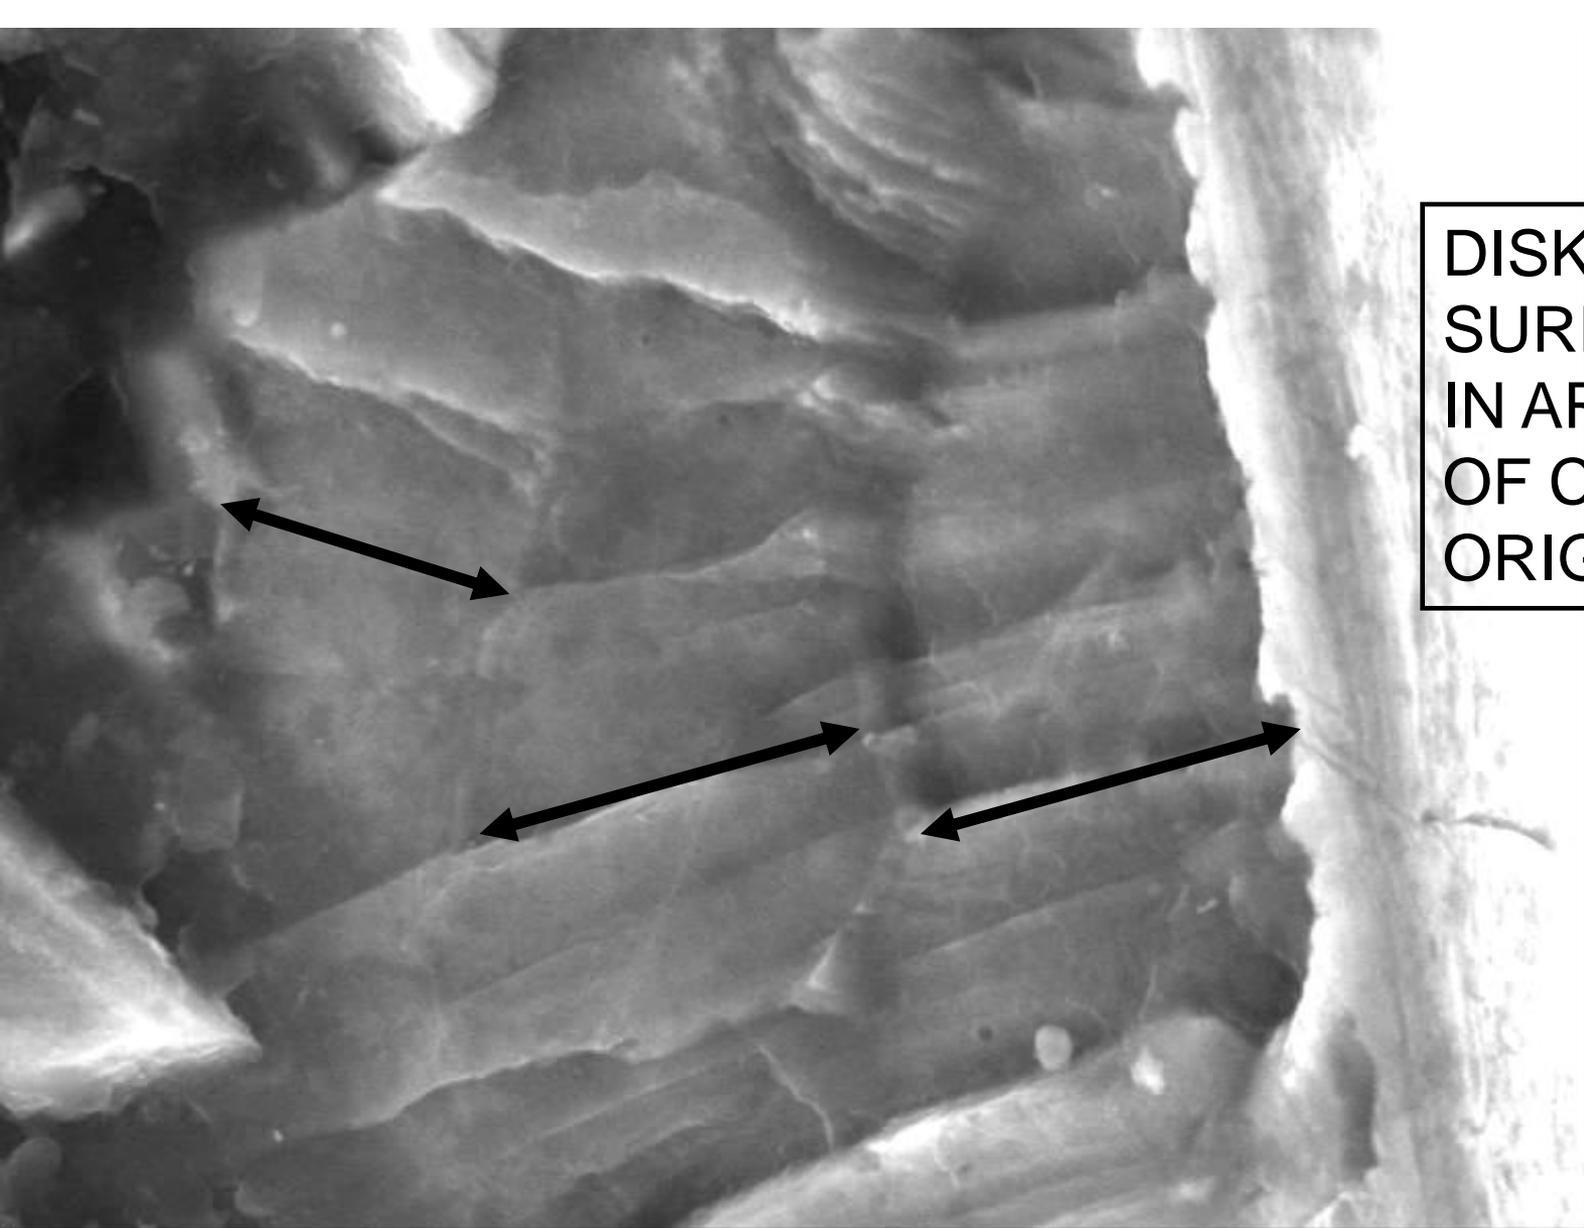
DISK No2
SURFACE
IN AREA
OF CRACK
ORIGINATION

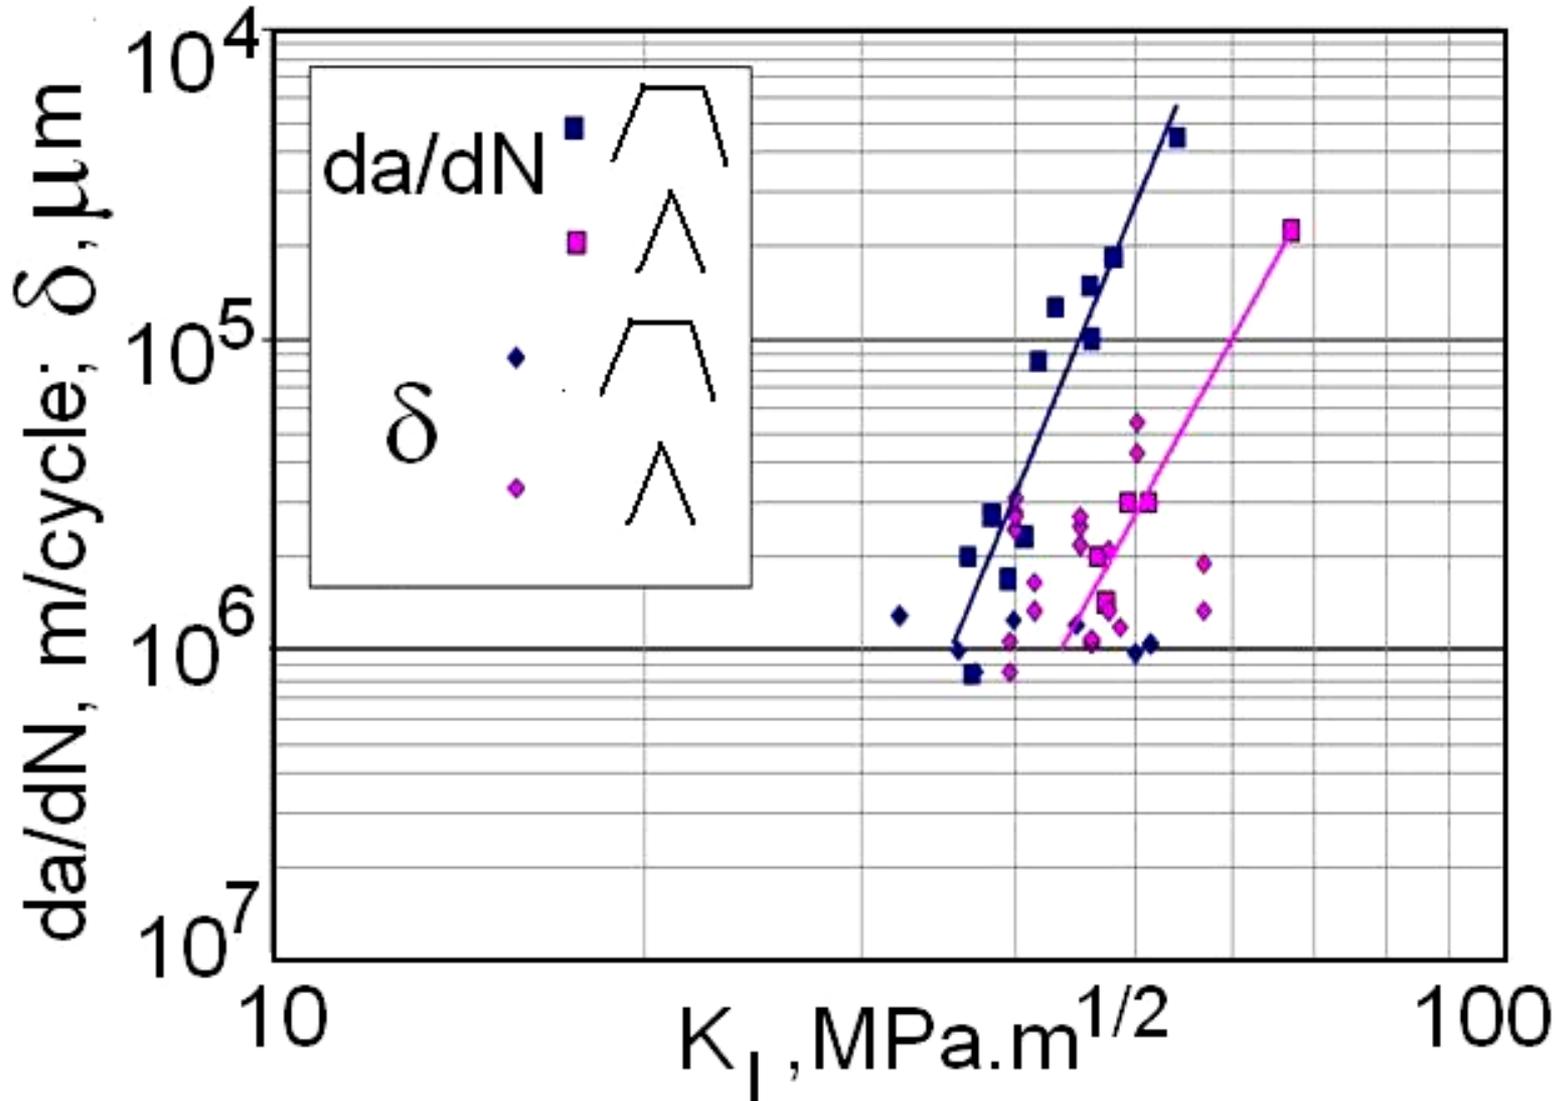
RESULTS OF SPECIMENS FATIGUE TEST AND FRACTOGRAPHIC ANALYSES FOR THE TITANIUM DISK No2 (6100 FLIGHTS TO FAILURE)

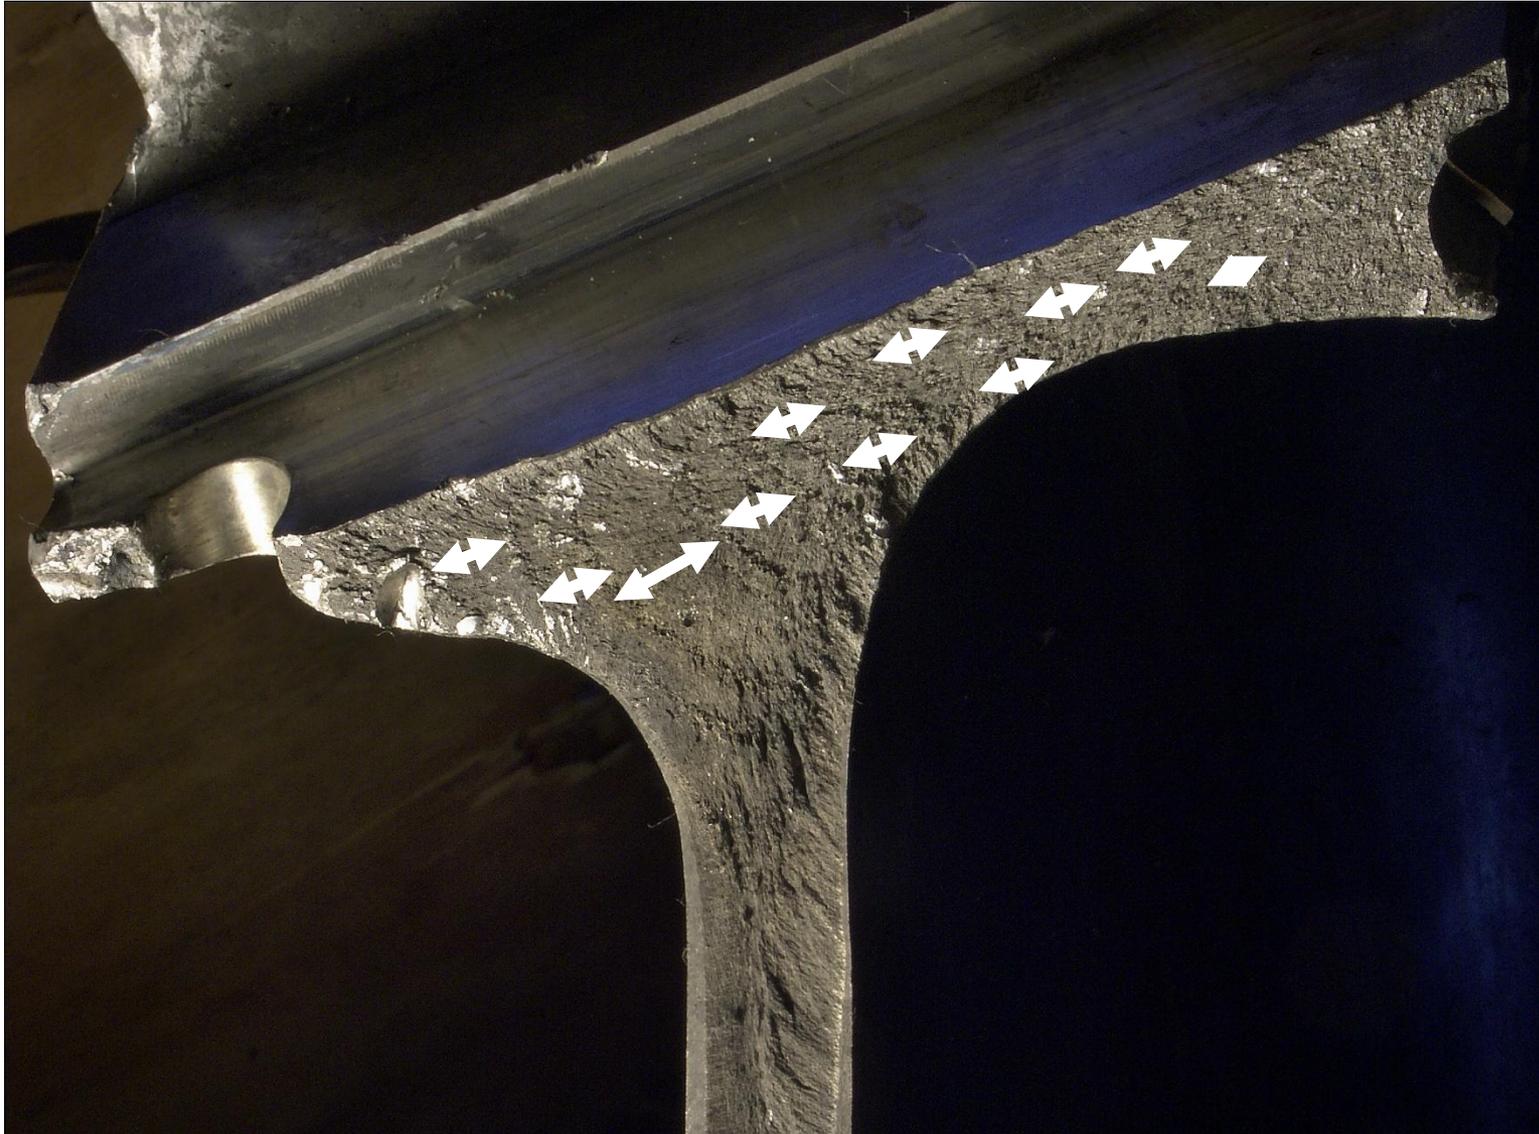
BLOCKS OF FRACTURE SURFACE REFLECTING
FOR DISK No2 NOT MORE THAN 25 FLIGHTS

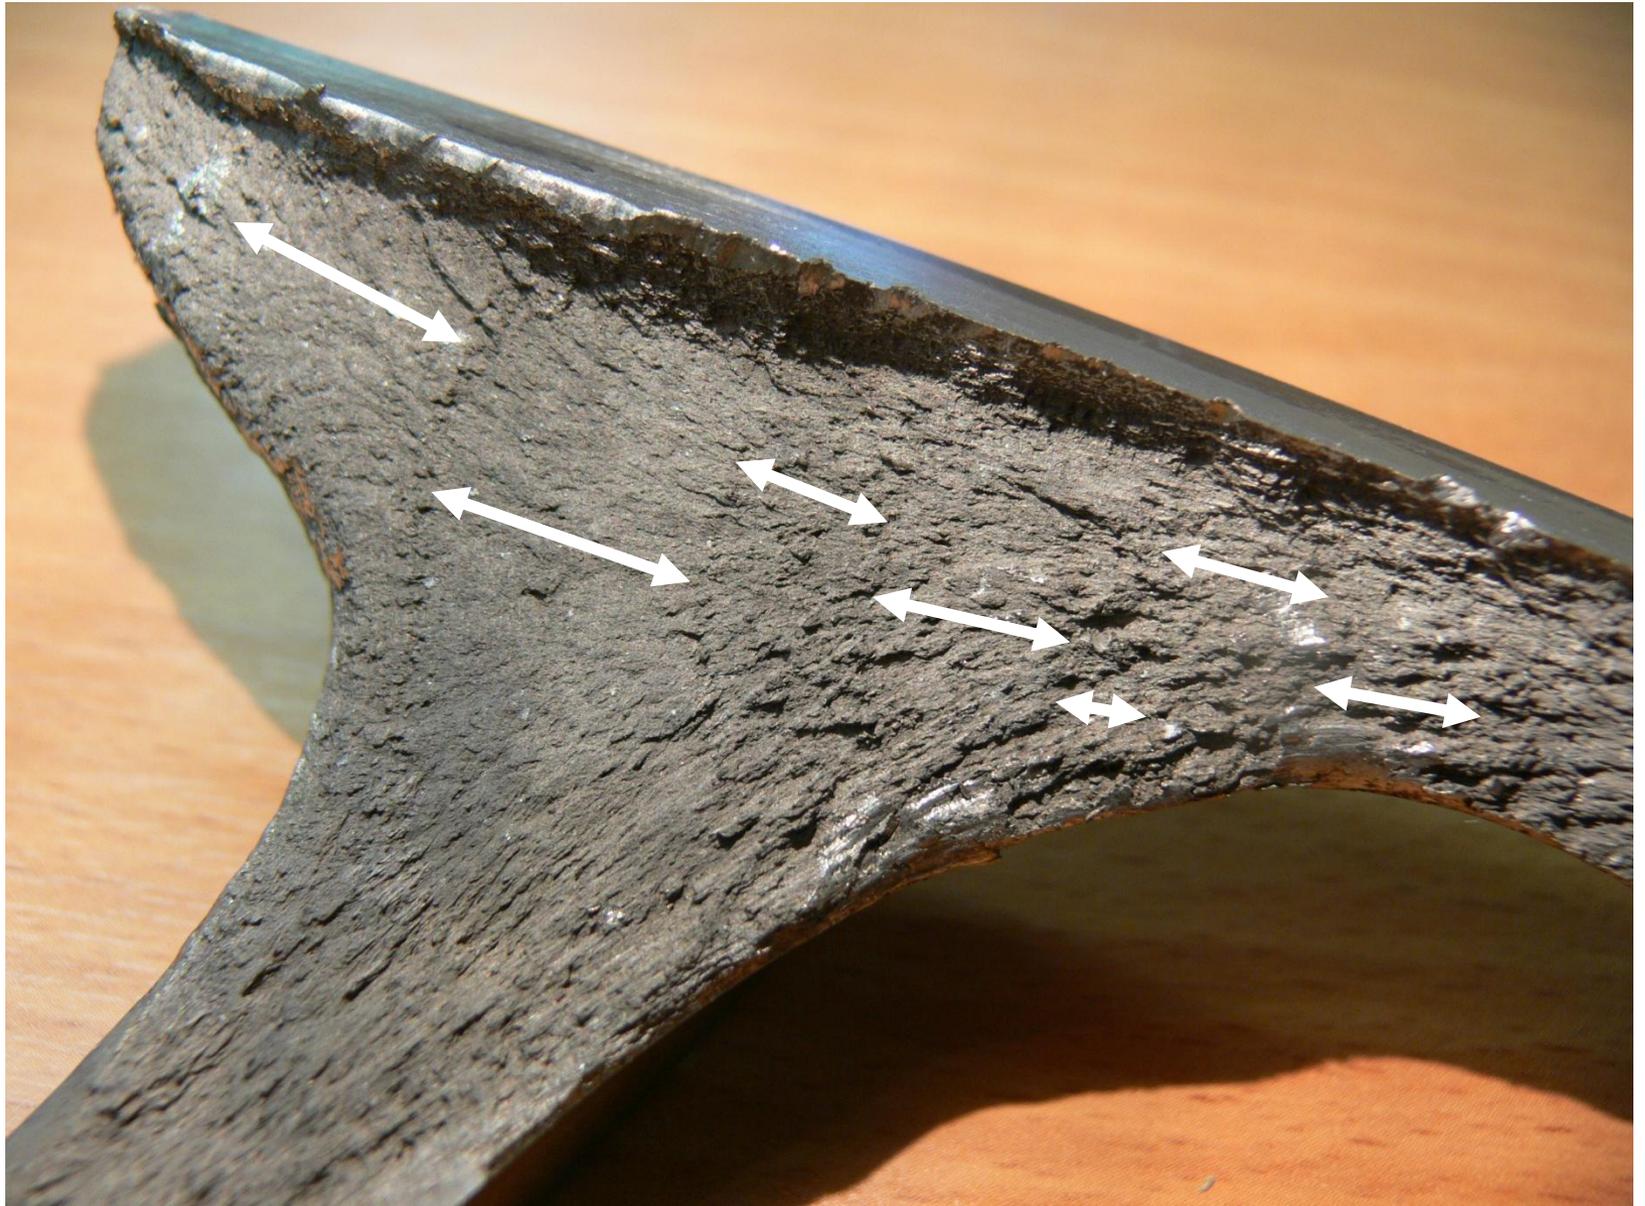
BLOCKS OF FRACTURE SURFACE REFLECTING
FOR DISK No3 NOT MORE THAN 15 FLIGHTS

TITANIUM DISK FATIGUE CRACKING OCCURS
NOT MORE THAN DURING **15 FLIGHTS**
BECAUSE OF **LCP+HCF** REGIME

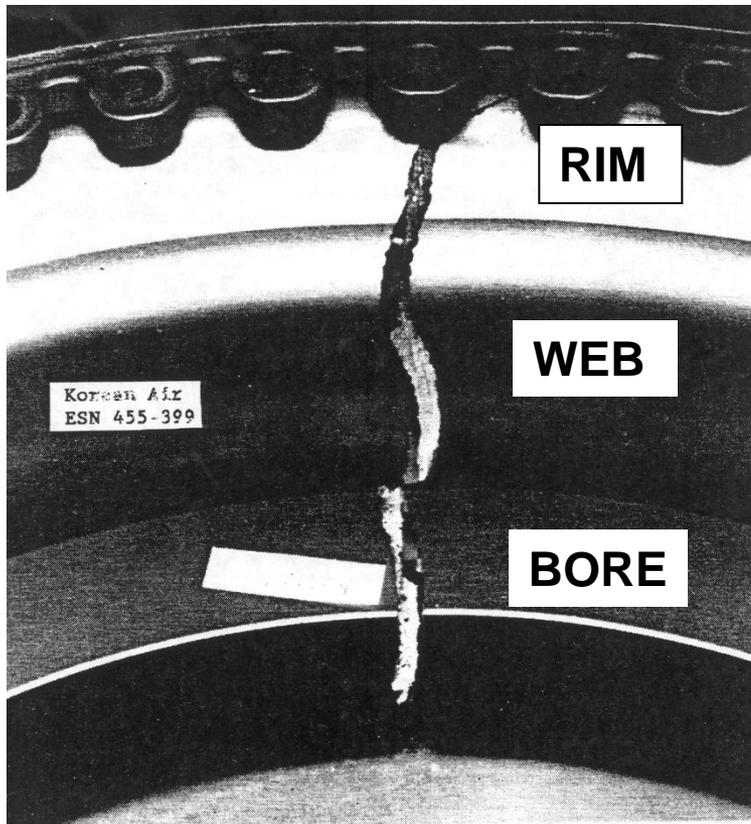
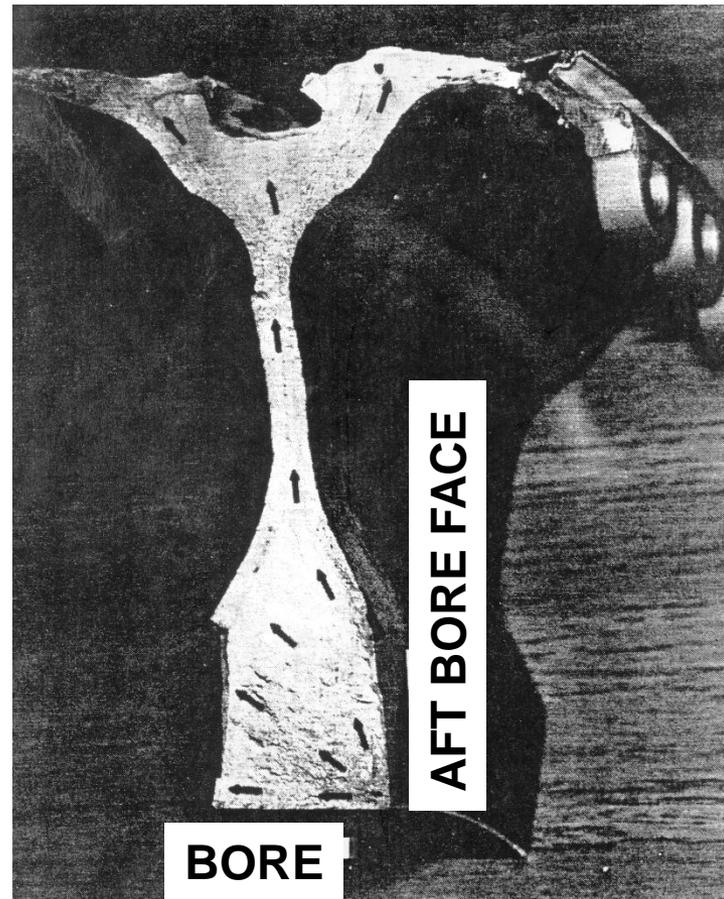
PHOTOGRAPH (a) DOCUMENTING THE AS-RECEIVED CONDITION OF **GF6-50 3-9 HPC SPOOL** That SUSTAINED a RADIAL BORE TO RIM SEPARATION IN THE STAGE NINE DISK. THE SPOOL WAS MANUFACTURED FROM 16" BILLET MATERIAL. CRACK INITIATION (b) OCCURRED FROM THE AFT-BORE CORNER REGION IN the STAGE NINE DISK AND PROPAGATED TOWARDS THE FORWARD SIDE OF THE DISK, UP THE WEB AND INTO THE RIM/SLOT BOTTOM. The AFT-BORE CORNER ORIGIN REGION EXHIBITED A GOLD OXIDATION TINT AND A VISUALLY EVIDENT REGION OF QUASI-CLEAVAGE FRACTURE.
