Synergetics of in-service titanium alloys fatigue cracking.

A. Shanyavsky,

*State Center for Civil Aviation
Flights Safety, Russia.*

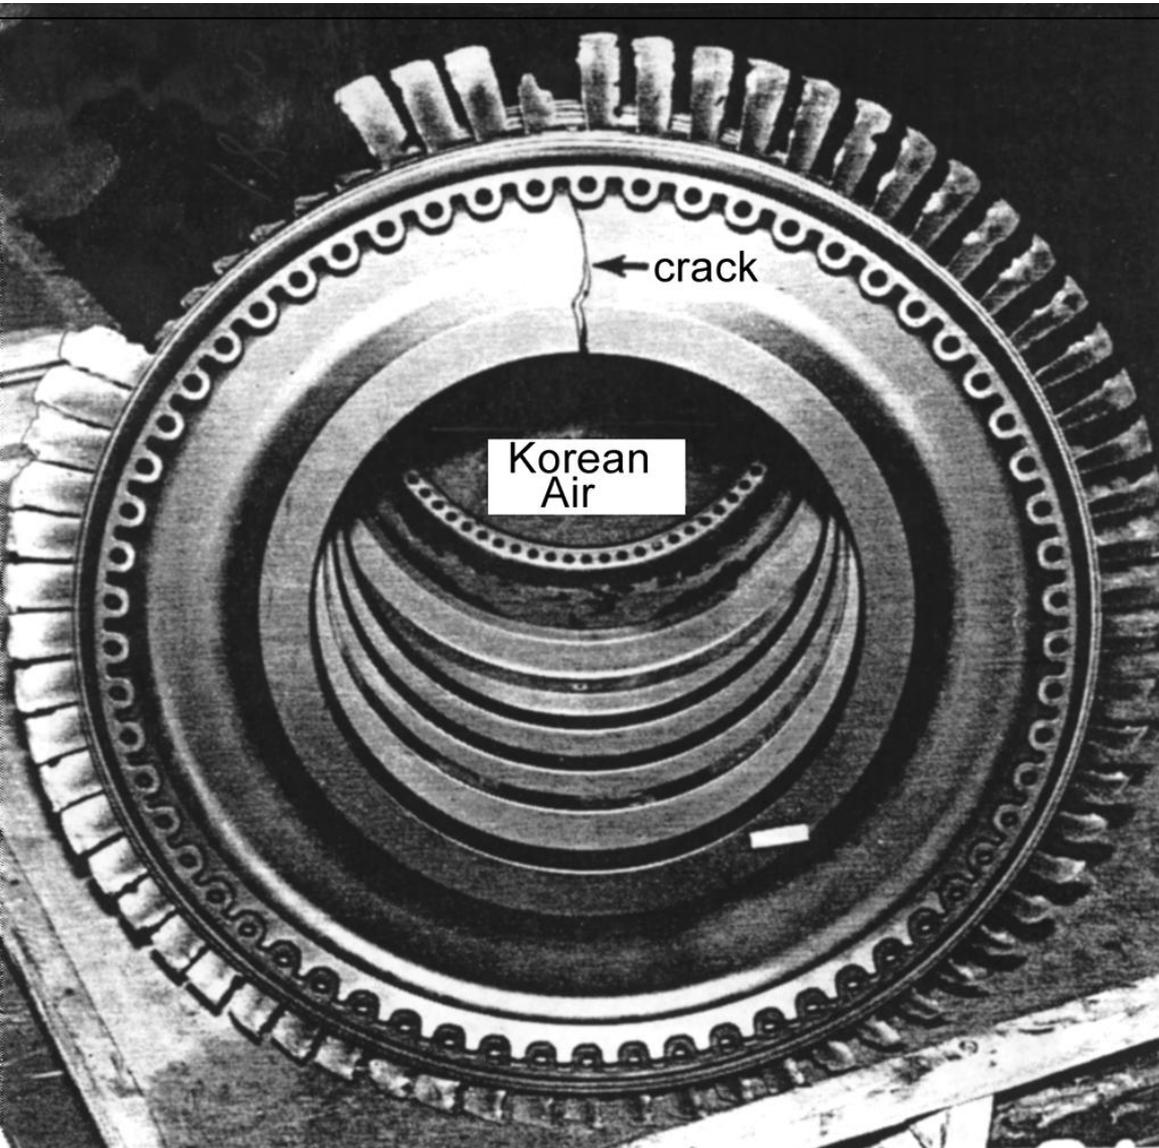
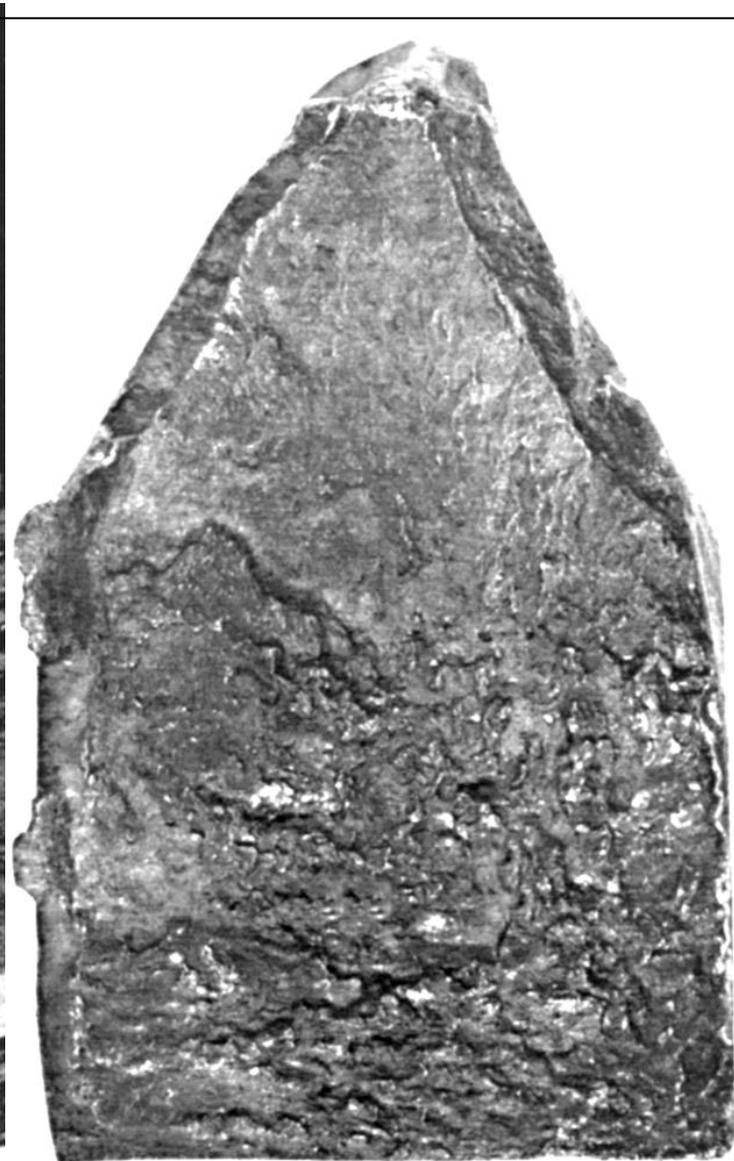
CRACK IN THE "KOREAN" TITANIUM DISK BORE OF THE 9-TH STAGE OF THE HPC SPOOL AND OPENED FRACTURE SURFACE. CRACK GROWTH – 1000 FLIHGTS.

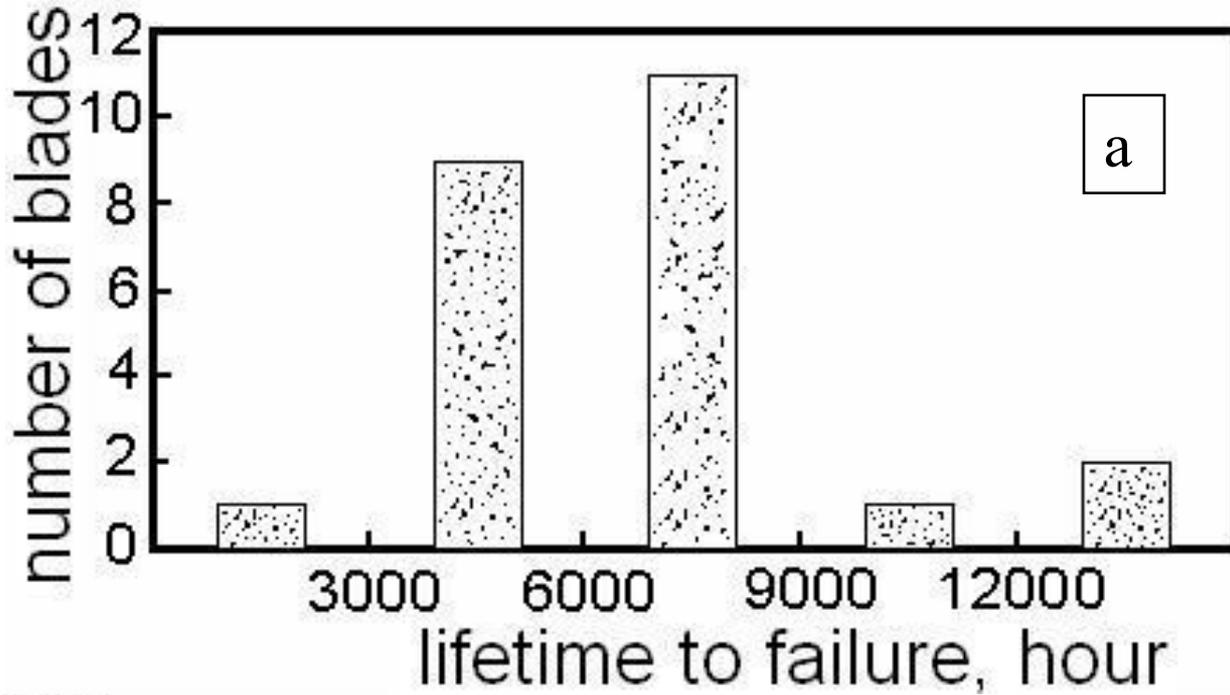
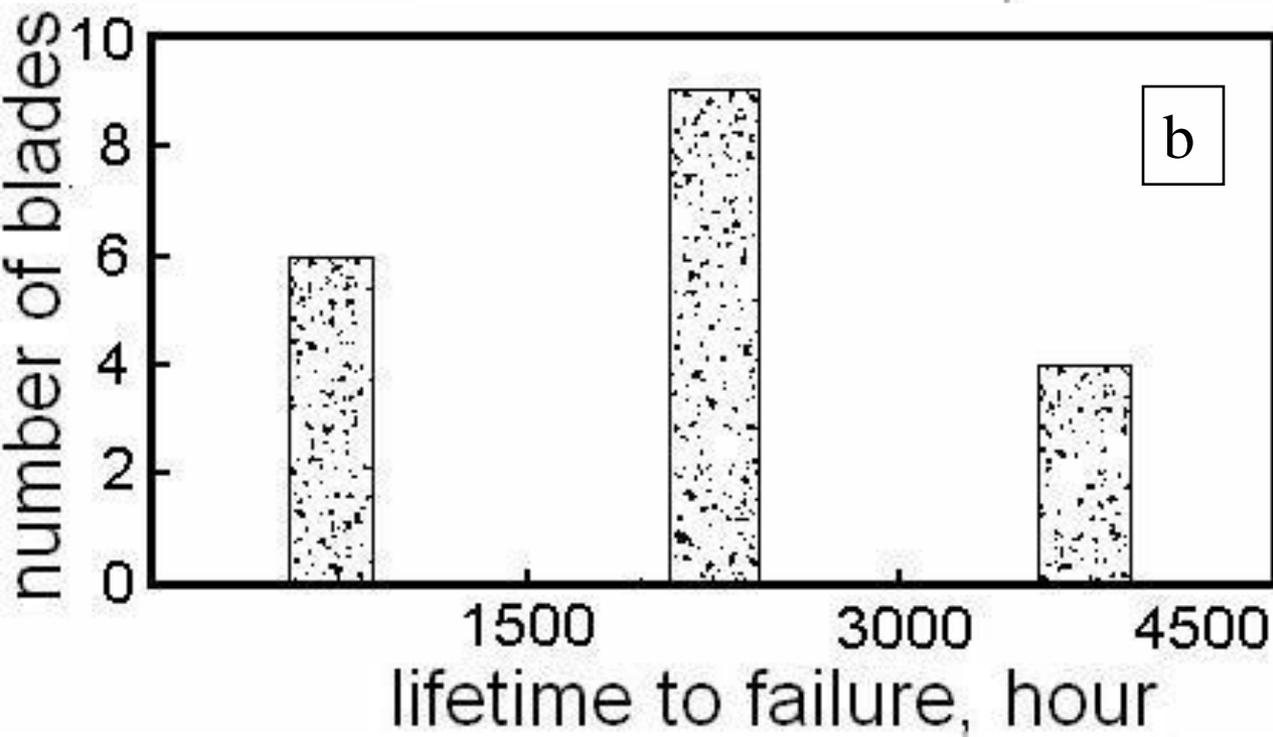
From this it follows, that, despite the intensive control and rejection of blades during repair, some of them can get into operation with sufficient depth of damage by BSs. In operating time after repair within the limits of 1500-2000 hours it is possible that blades can experience free vibrations because of the loss of contact of the BSs.

Number of cracked bandage shelves of the compressor blades of the titanium alloy **VT8** in versus (a) full and (b) after last repair lifetime to failure.
