Synergetics of in-service titanium alloys fatigue cracking.

A. Shanyavsky,

*State Center for Civil Aviation
Flights Safety, Russia.*

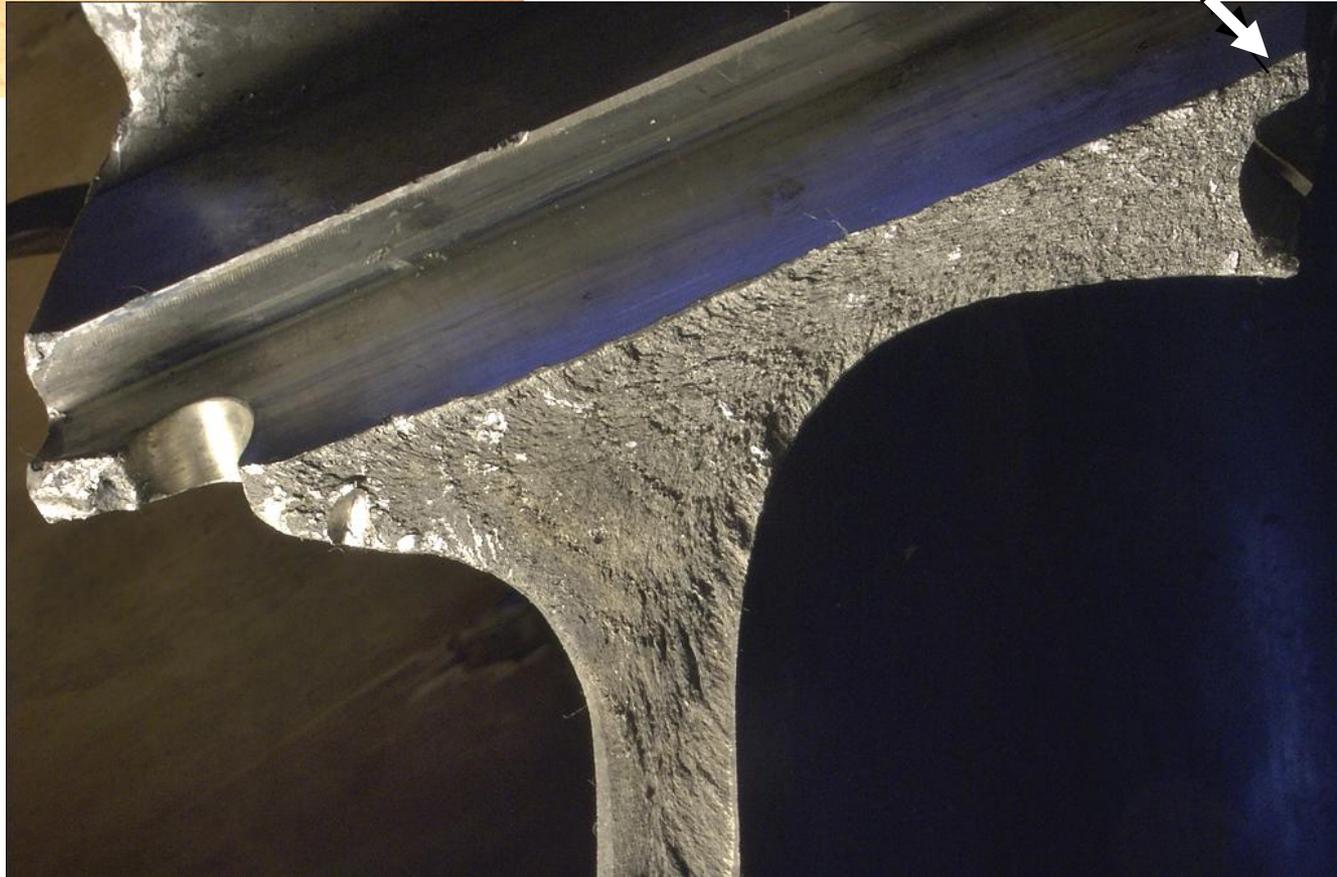
**TITANIUM DISKS FAILURES
IN HCF-LCF REGIME; ENGINE D-30KU**

NUMBER OF FLIGHTS: No1 – 1000;
No2 – 6100;
No3 - 9700

ORIGIN

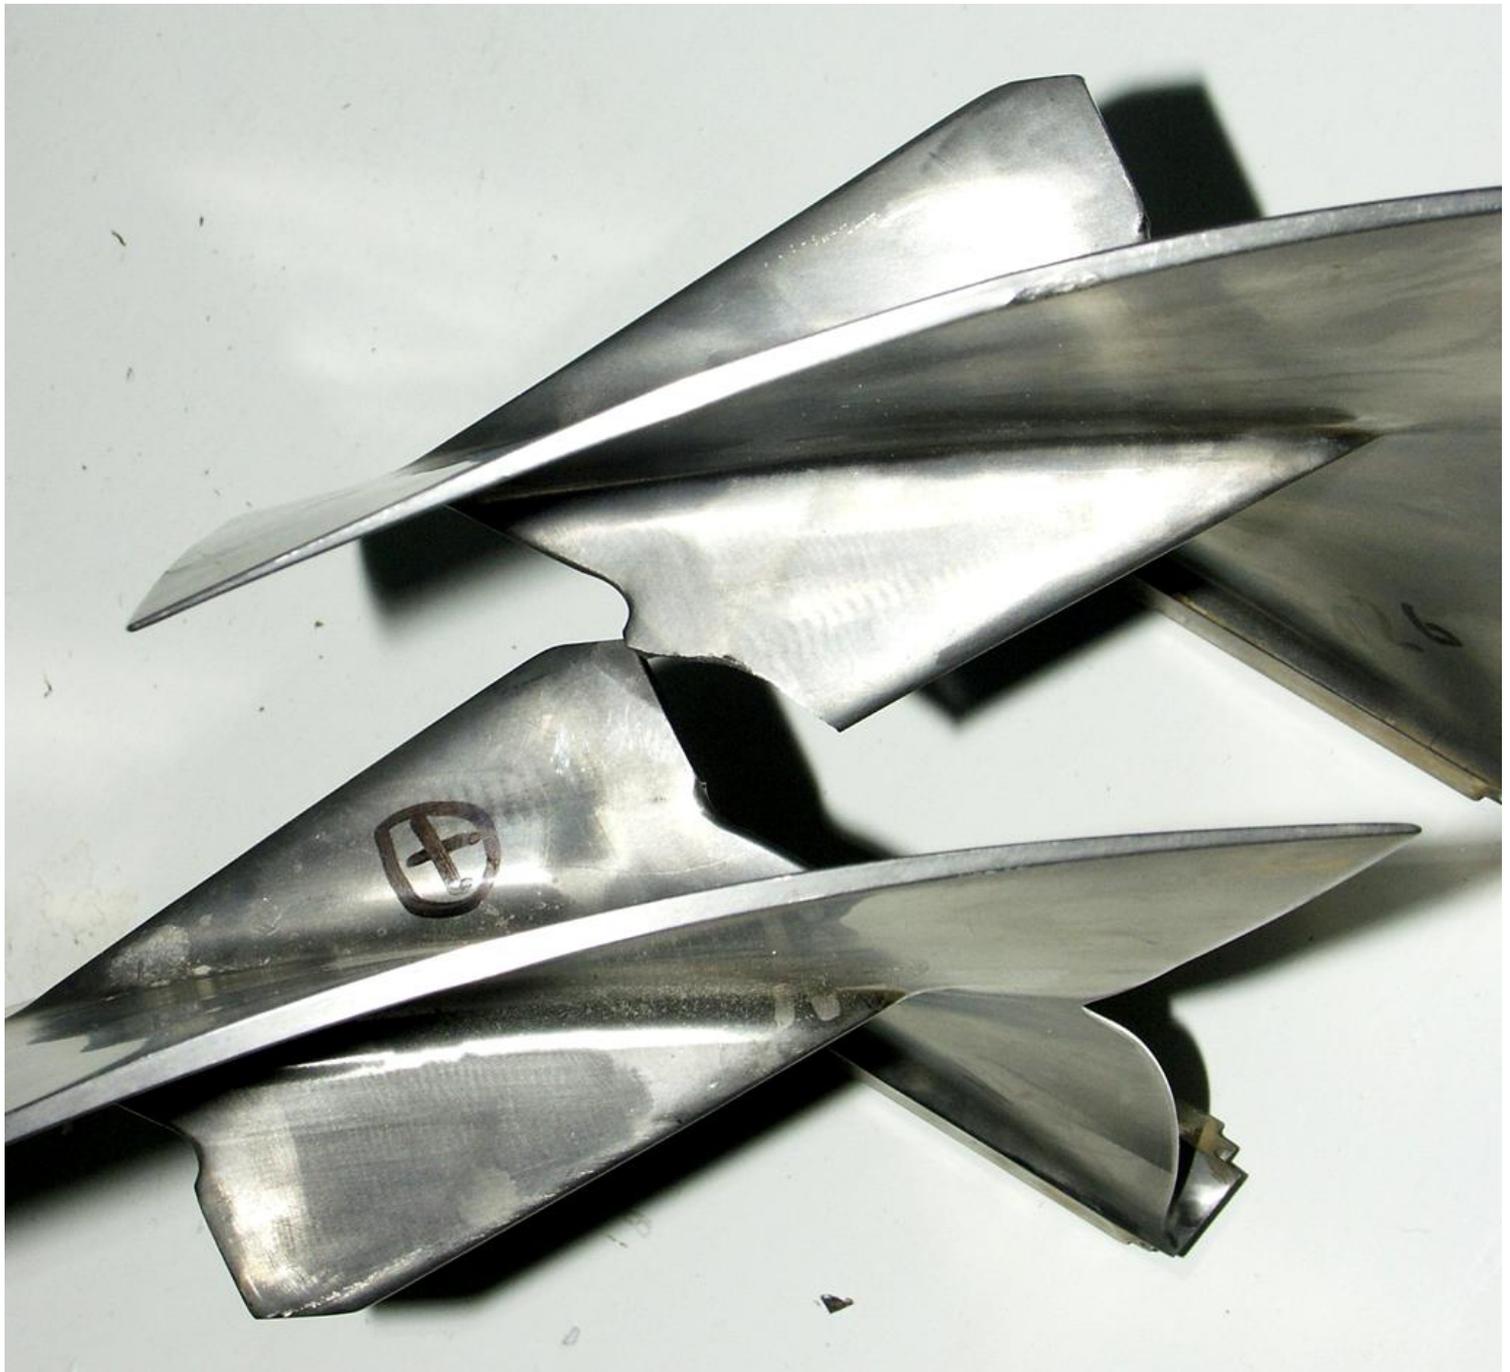
origin
